# inspection procedure | EMV

## excavator mounted vibrator

general maintenance procedure

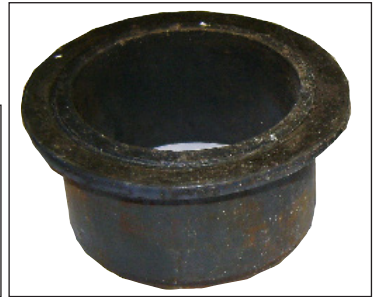
Severe wear to pin

Wear to adaptor

Wear to bush

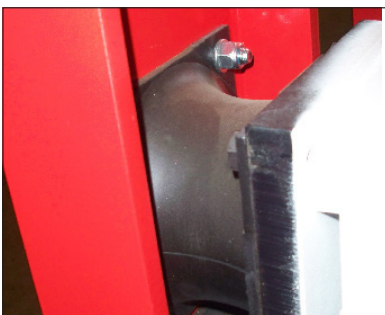
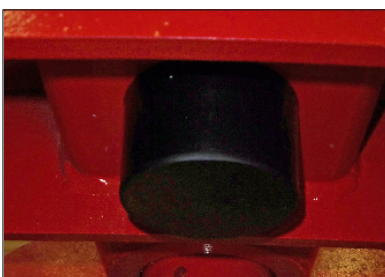
# saddle assembly

- Visual inspect saddle for cracks
- Check sandwich mounts for splits / damage

- Check bump stops for damage

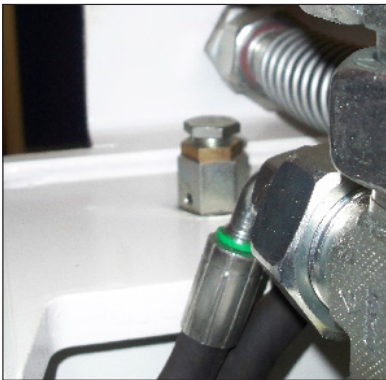
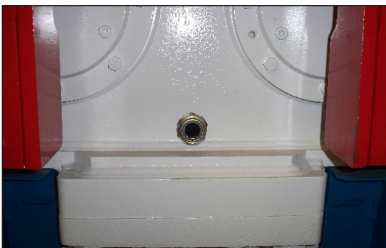
# gearbox assembly

Photo of EMV450

Photo of EMV300

- Check general condition
- Check temperature of bearing - (Run on test pile for 15mins, check and compare, temperatures on bearing caps should be even)
- Visual check for oil leaks - Bearing Cover / Gasket
- Ensure all bolts are tight

Damage to motor due to incorrect fitting of drain line

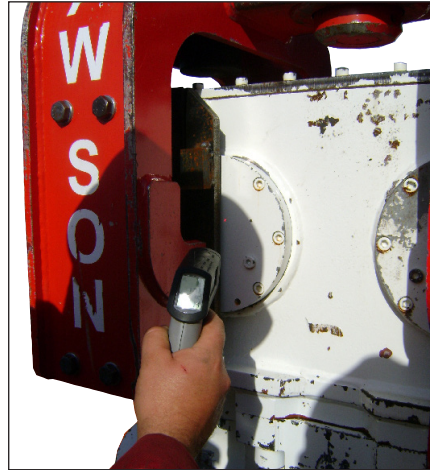
Temperature check on bearings with laser temperature gun

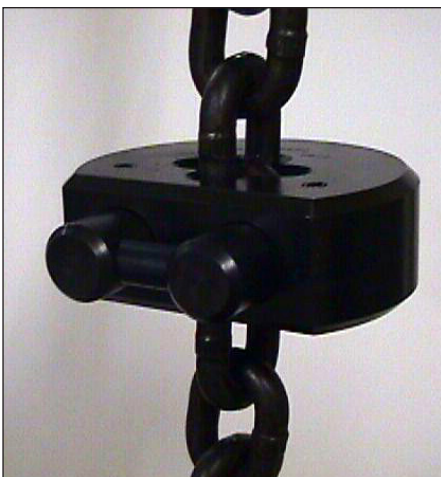
- Inspect chain clamp where fitted for damage

Chain clamp on EMV300

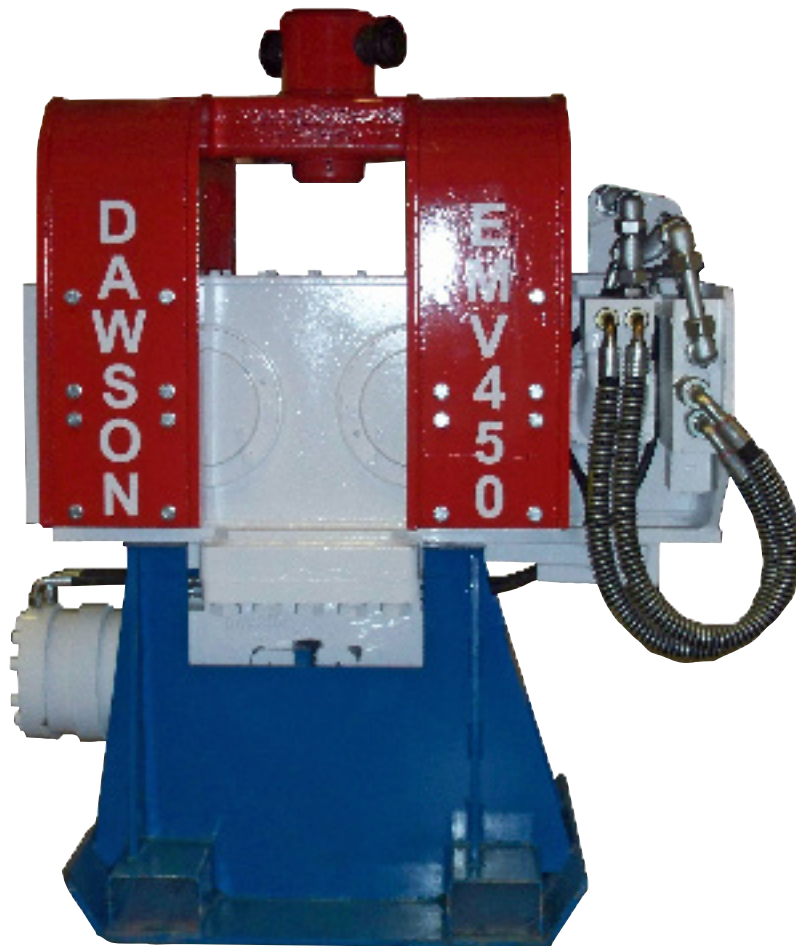
- Inspect general condition of stand
